## Case Study: 4,500 tonne UK Ammonia Plant Dismantled for Relocation and Reassembly

### *The final piece in a vast jigsaw puzzle*

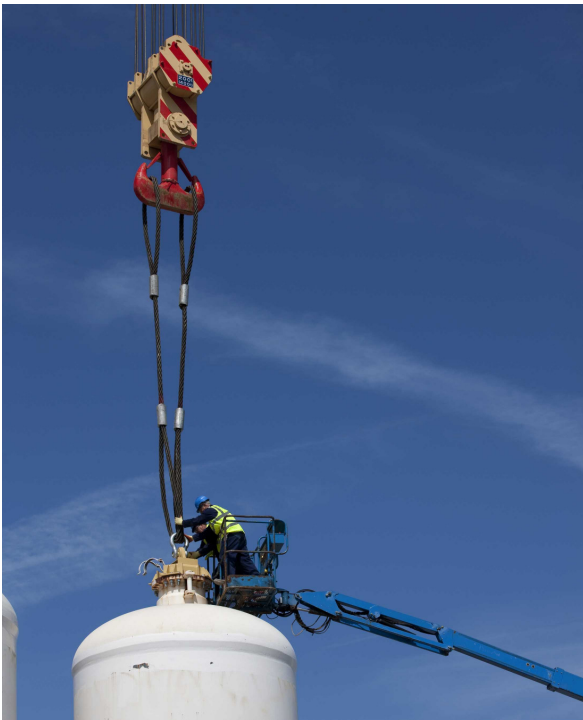
Smaller vessels and pipework were tightly packed into containers, while larger components such as a range of 42 tonne PSA (pressure swing adsorption) vessels were lifted by crane and loaded onto heavy haulage vehicles.

Due to the design of the tank-like PSA vessels, it was necessary for the contractor to manufacture a bespoke attachment to aid the lifting process. Once this shackle was connected to the top lifting point of the tank, the seal to the floor was cracked and a 450 tonne crawler crane lifted each tank clear in a vertical position. The hook of a smaller 160 tonne crawler crane was then attached to the tailing lifting point at the base of the vessels, to enable the tank to be lifted into a horizontal position for transportation.
